Case Study

Pushing Power to Position a Conductor Repair Clamp

PRODUCT: CONDUCTOR CLAMP POSITIONING TOOL

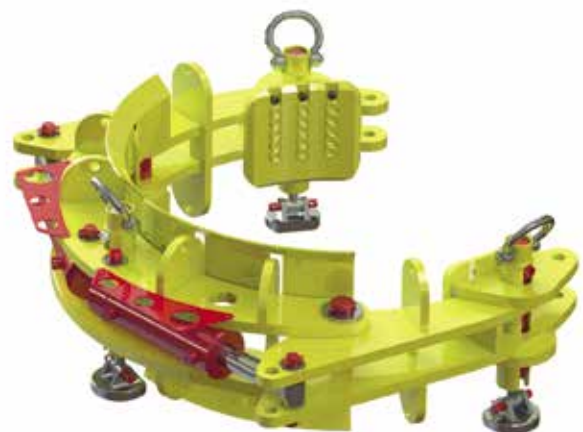
- Unity designed a tool to provide over six tons of push force onto the repair clamp, while at the same time gripping the conductor, resisting the reactions of the push rams. The rams used to push the clamp provided 200mm of travel.
