# Case Study

## Centralisation Clamp Prevents Well Movement and Damage to the Conductor Casing

PRODUCT: WELL CENTRALISATION CLAMP

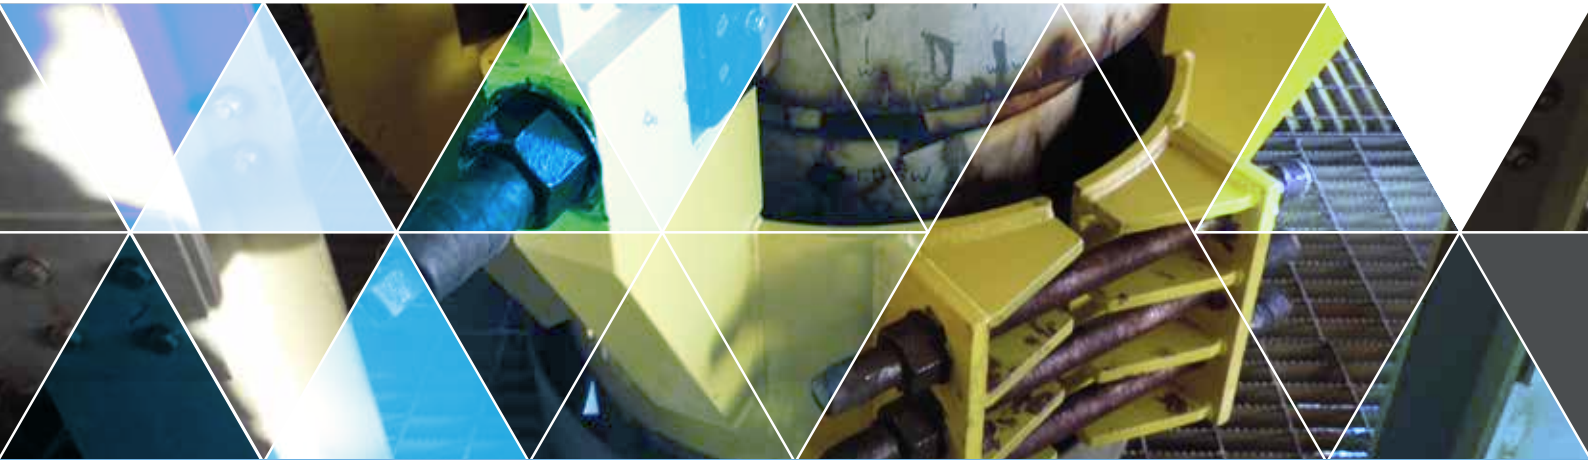
A well in the northern North Sea was experiencing excessive movement between the conductor and surface casing due to a damaged centraliser. After running cameras, the client discovered that this movement combined with the loose/damaged centraliser had been scoring into the casing causing integrity concerns.

- Unity engineered a robust well clamp that centralised the well and prevented further scoring of the casing by the damaged centraliser.
- The design incorporated six load fins, each capable of withstanding a twenty five ton load.
- Removable and replaceable wear pads in the load fins were incorporated to prevent metal-to-metal contact with the inner casing string.
- The clamp was assembled in two parts for easy installation by two people in one day.

Unity were tasked with designing a Centralisation Clamp to limit the movement of the well within the conductor, therefore preventing any further damage to the casing.

- The entire project was completed within eight weeks of the initial discussion with the client.
- Over £500,000 was saved when compared to the alternative repair option of replacing part of the conductor and installing a new internal centraliser.
